INDOOR AIR QUALITY ASSESSMENT

**Roxbury District Court
85 Warren Street
Boston, Massachusetts**

Prepared by:
Massachusetts Department of Public Health
Center for Environmental Health
Emergency Response/Indoor Air Quality Program
April 2006

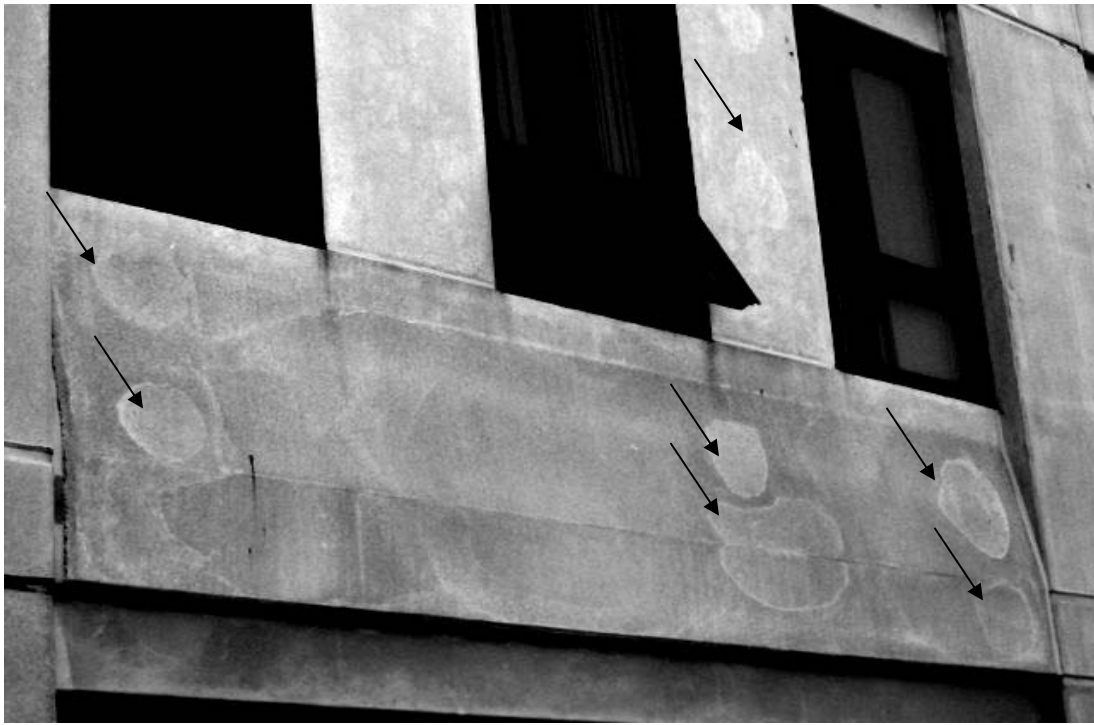
Picture 35b

Picture 34a with contrast altered, revealing water stain patterns on exterior wall panels (Arrows)

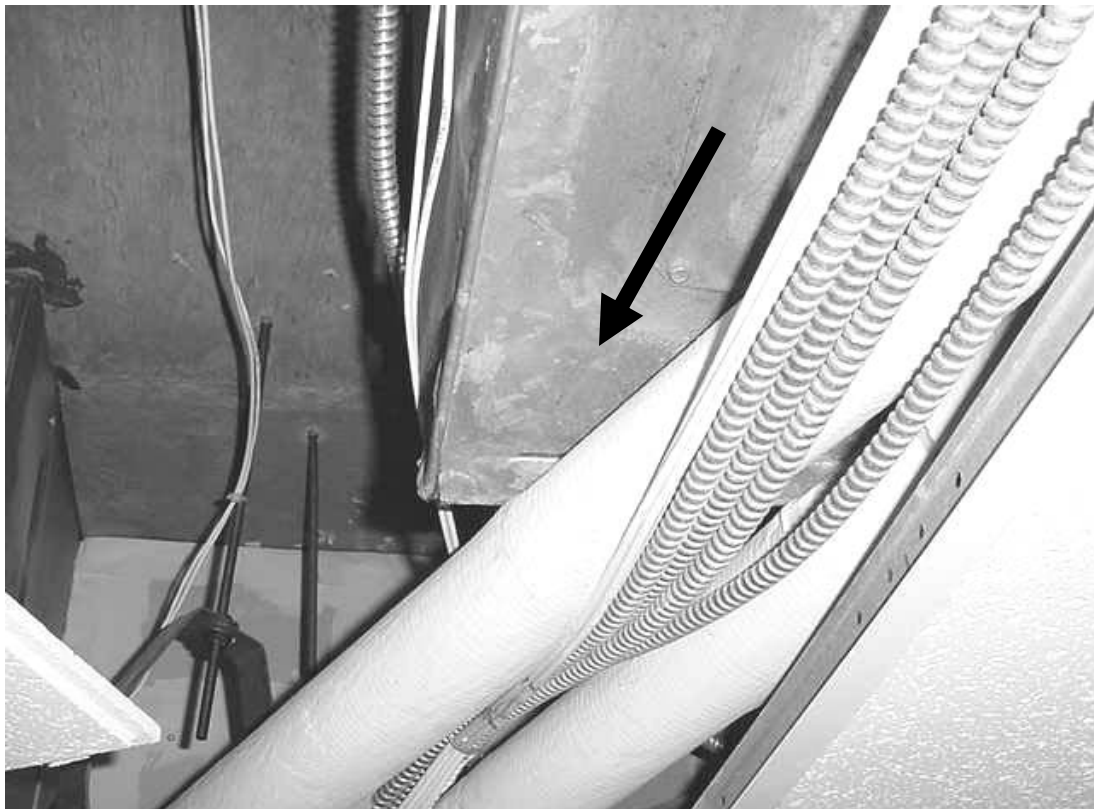
Picture 36

Exhaust vent ductwork leak water, note water stains at corner (Arrow)

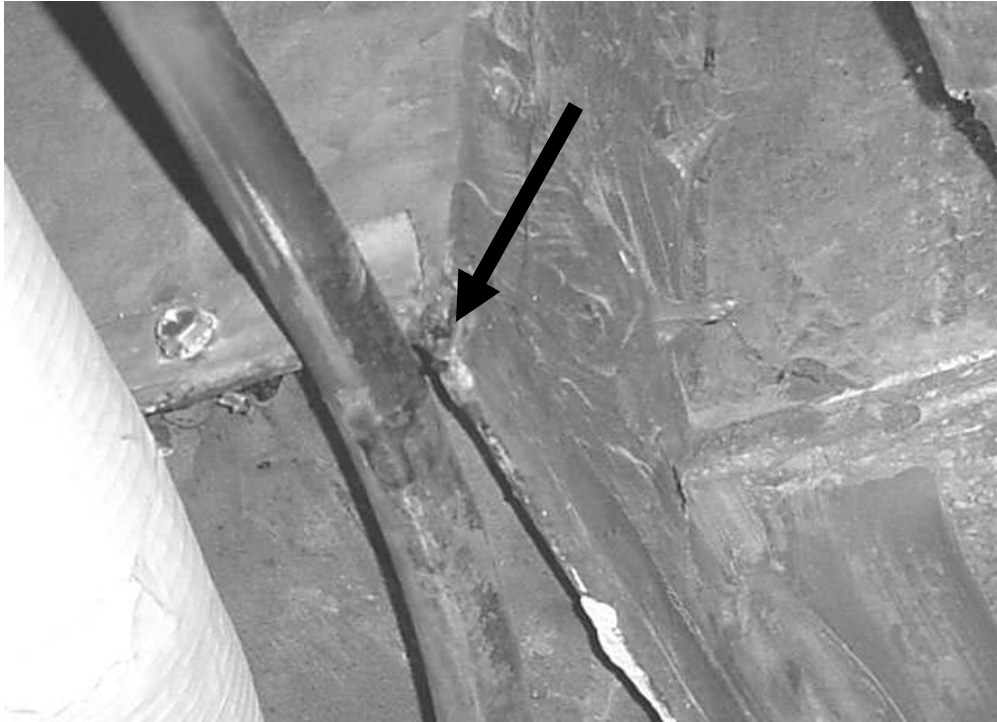
Picture 37

Exhaust vent ductwork leak water, other seam of duct leaking water (Arrow)

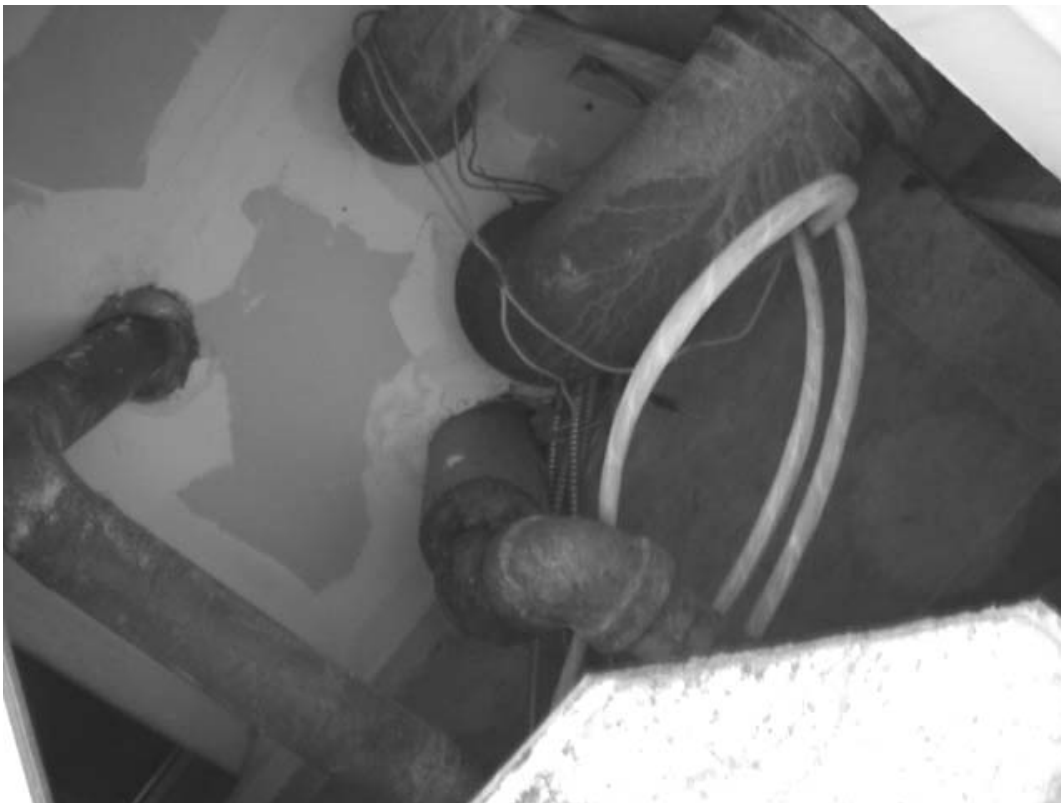
Picture 38

Pipes in a chaseway located in the ground floor of the RDC were found to be heavily corroded with rust (Picture 38). Water stain patterns on the rust on this pipes suggests water traveling along the exterior of the pipes, which can indicate either a leak from the drain installation in the roof or a leak from a joint of the pipes.

Rusty pipes in chaseway

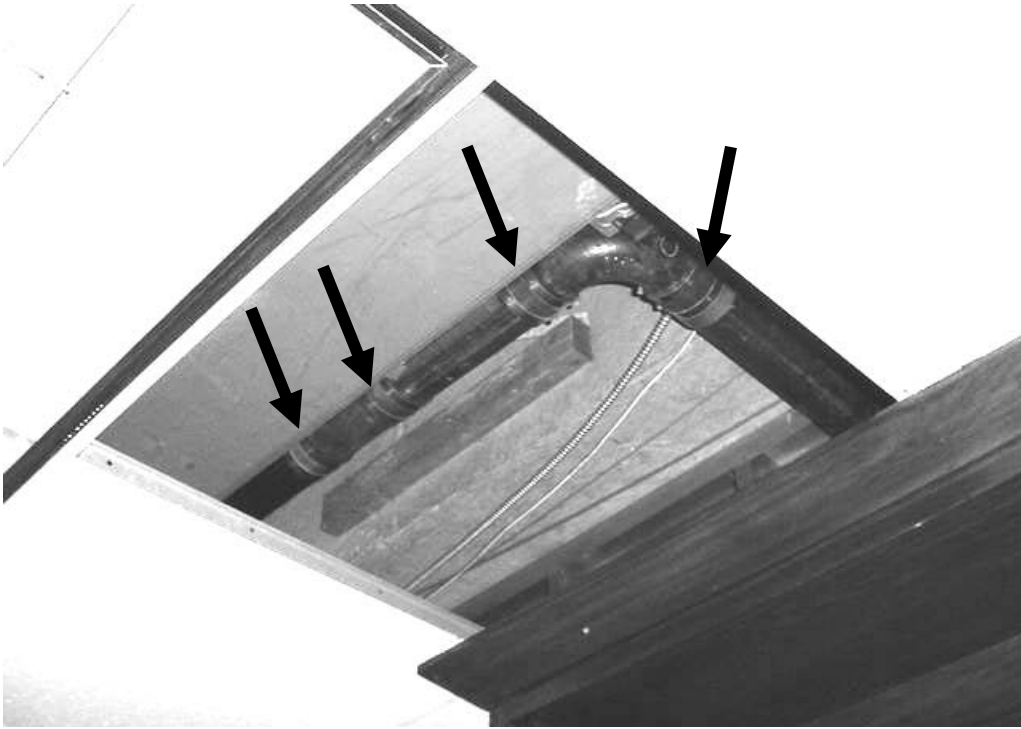
Picture 39

Rubber Gasket screw clamps on single pipe (Arrow)

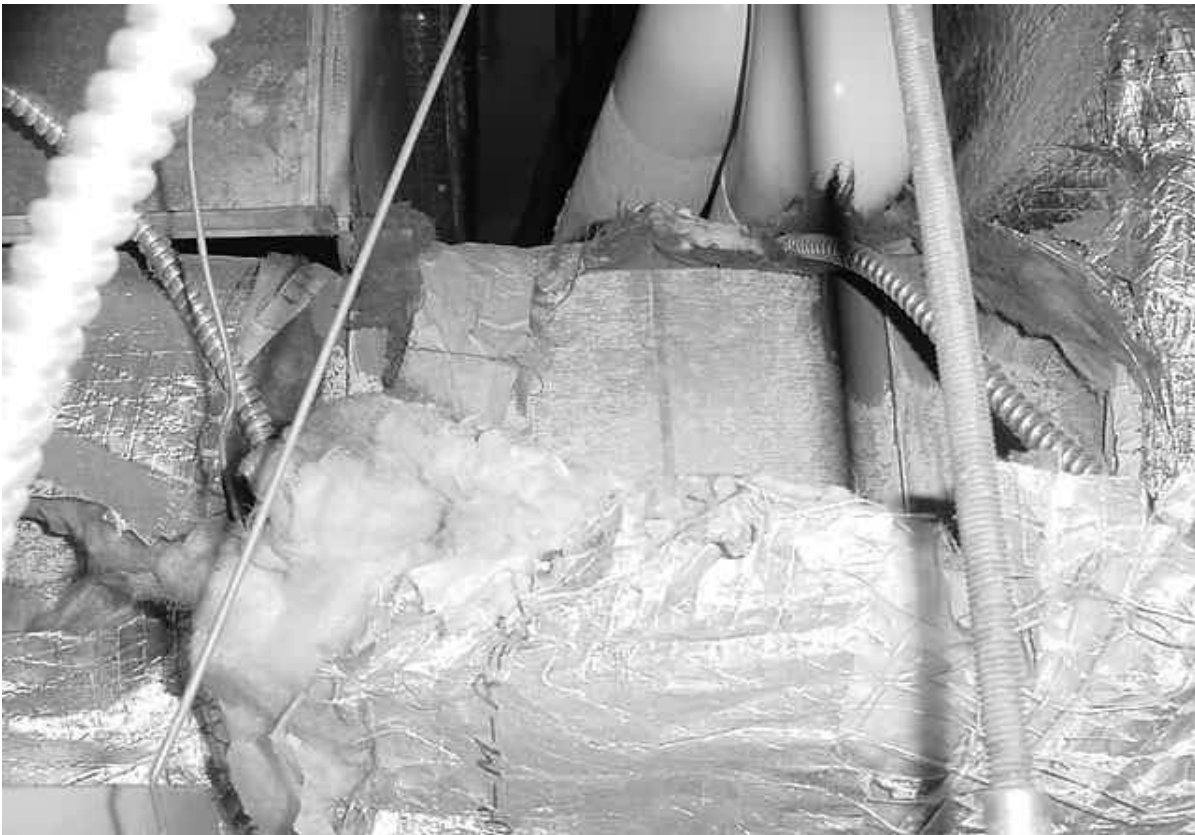
Picture 40

A significant number of water-damaged ceiling tiles were located beneath pipes that supply chilled water for the HVAC system components. Missing and damaged insulation was observed in some areas above the ceiling tile system (Picture 40). When warm, moist air passes over a surface that is colder than the air, water condensation can collect on the cold surface. Over time, water droplets can form, which can then drip from a suspended surface. For this reason, HVAC systems pipes that provide chilled water are insulated. Pipes with either water-damaged or missing insulation are prone to generating condensation, which in turn beads into water droplets and fall downward to wet ceiling tiles.

Missing Damaged Duct Insulation above Ceiling Tile System in Room 314

8. Repair/replace damaged insulation around ductwork in room 314 (Picture 40), as well as other areas to prevent condensation.
9. Use local exhaust ventilation and isolation techniques to control remediation pollutants. Precautions should be taken to avoid the re-entrainment of these materials into the building.

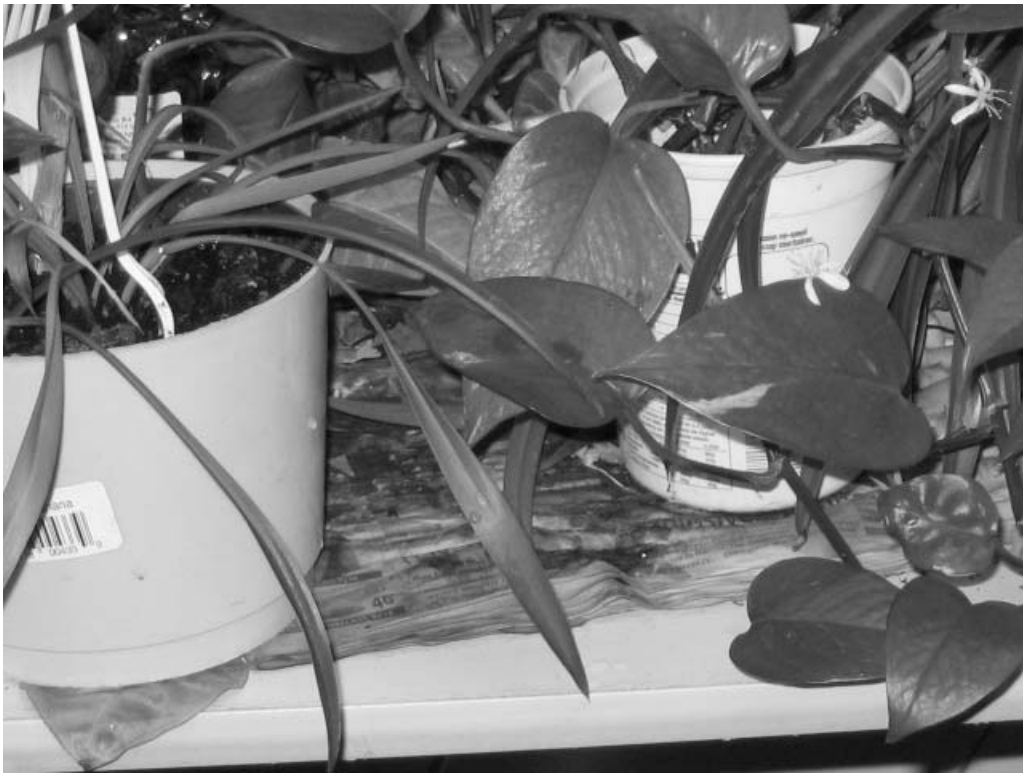
Picture 41

Plants on paper print material

7. Ensure all plants are equipped with drip pans that are made of a *non-porous* material. Examine drip pans for mold growth and disinfect areas of water leaks with an appropriate antimicrobial where necessary. Move plants away from ventilation sources. Consider reducing plants in some areas.

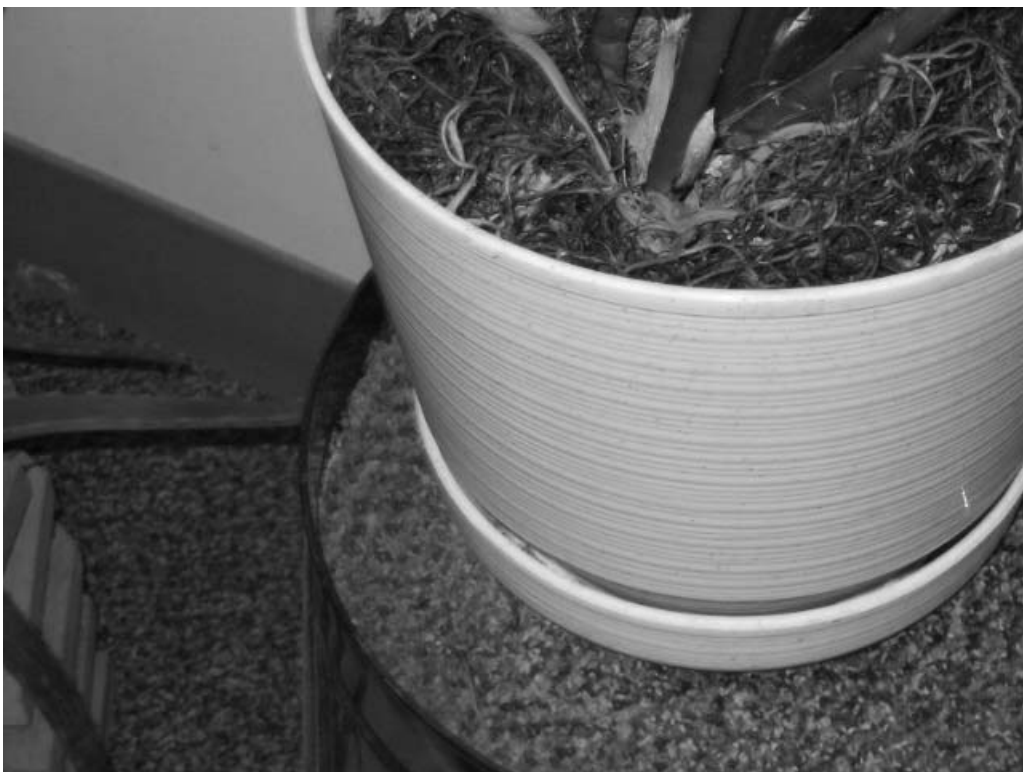
Picture 42

Plant on carpet cutout

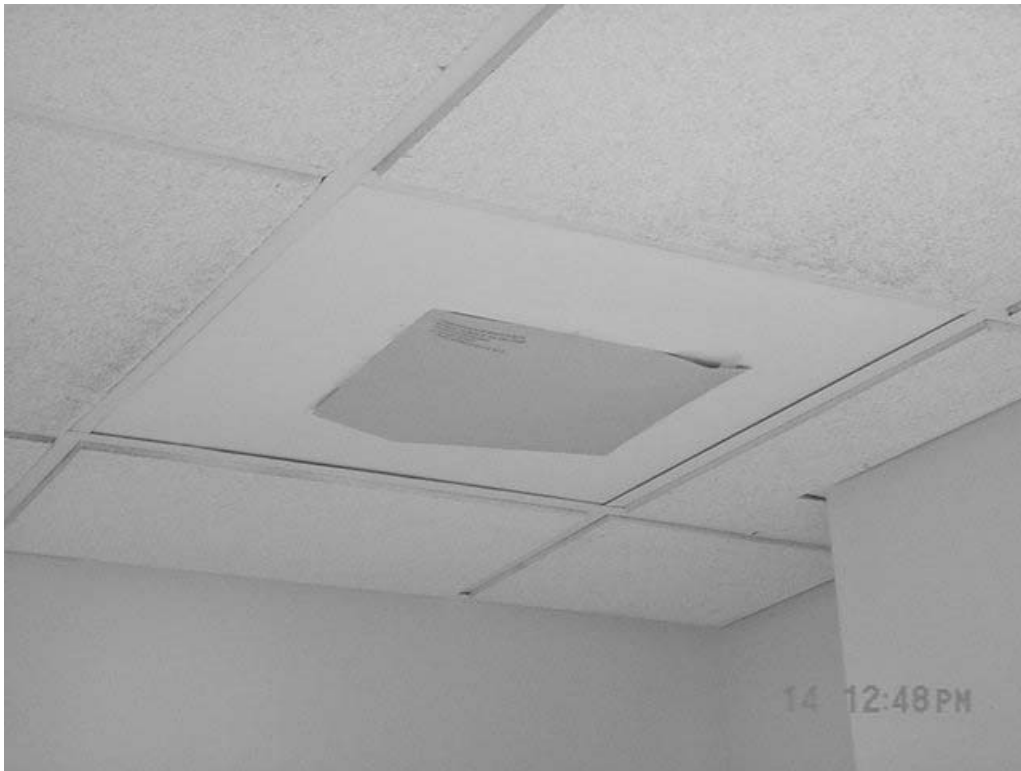
Picture 43

Sealed supply vent

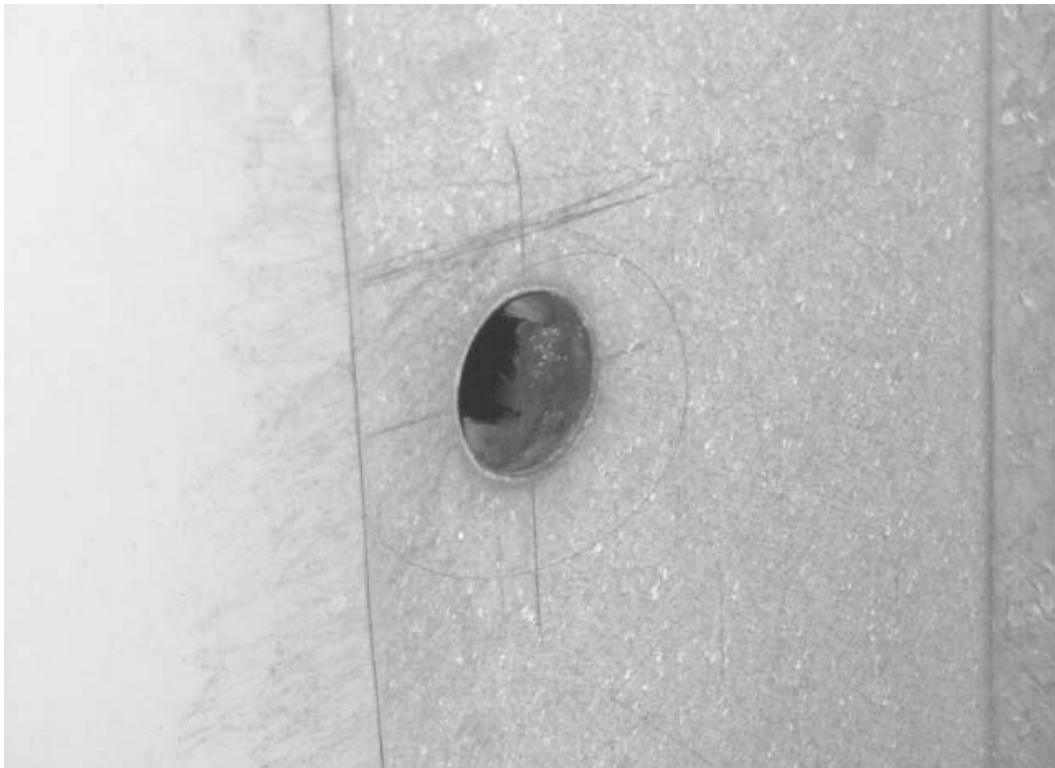
Picture 44

CEH staff inspected AHUs in the penthouse and found that three of the four units had holes in the sheet-metal housing (Pictures 44 and 45). This is important to note because the location of the breaches were *post-filter*. As air is forced through the AHU it becomes

Hole in Penthouse AHU Casing (Post Filter)

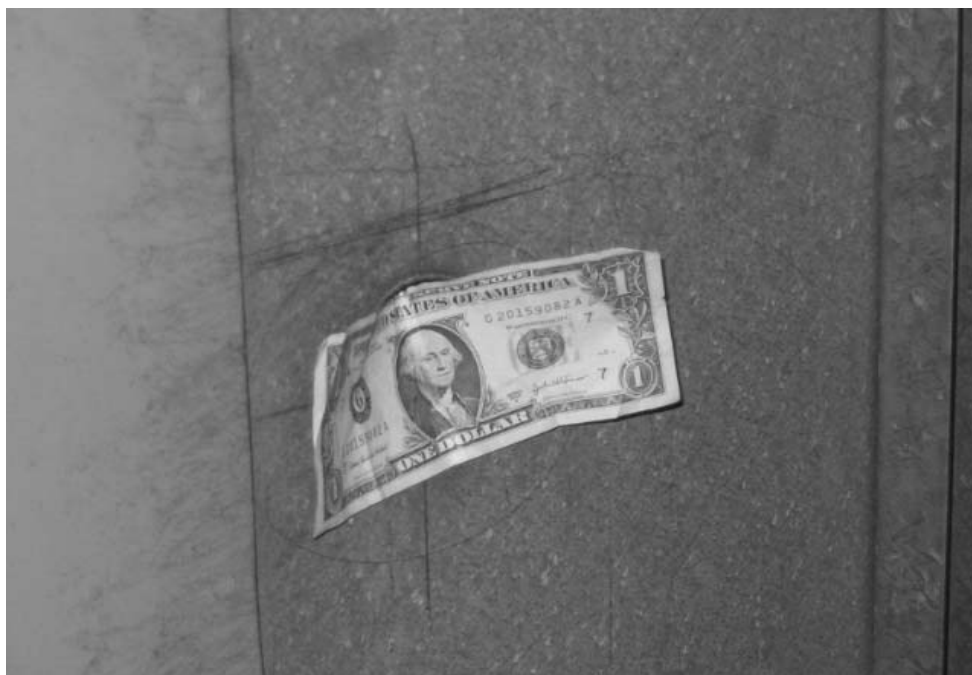
Picture 45

Hole in AHU Casing in Picture 40 with Dollar Bill held on casing by draw of air into Unit to Illustrate Entrainment

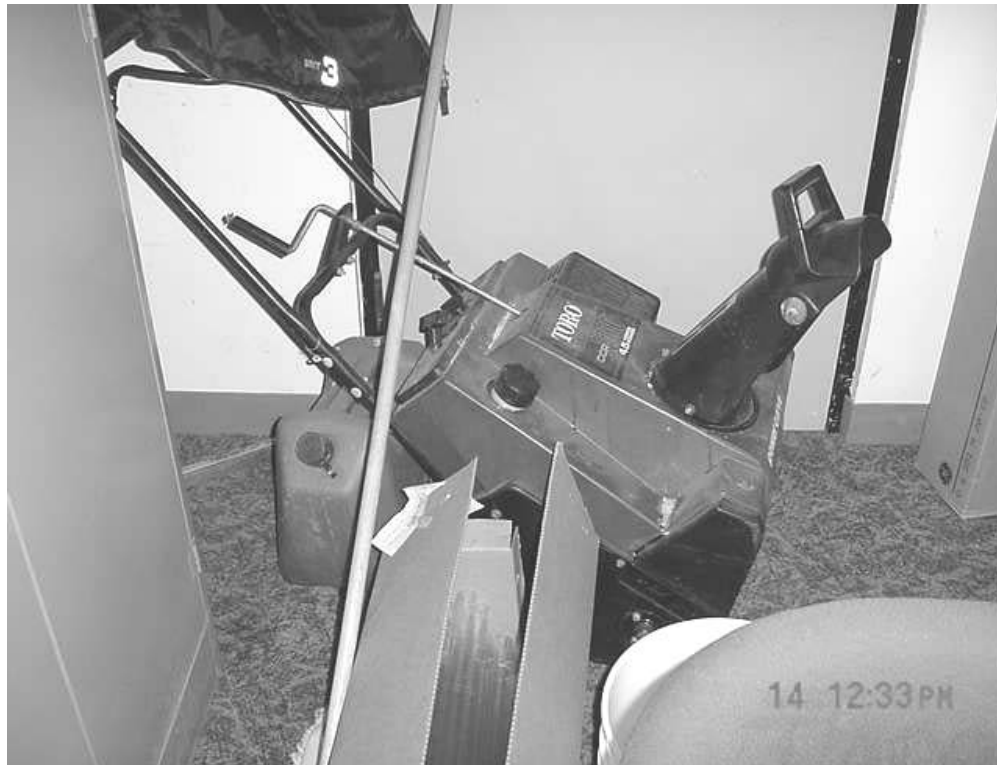
Picture 46

A gas-powered snow blower and gasoline container were being stored in the ground floor hallway, near office space (Picture 46). Odors and off-gassing of VOCs from gasoline can have an adverse effect on indoor air quality. In addition the storage of these items indoors can pose a fire hazard.

Snow Blower and Gas Can Stored inside Ground Floor Hallway
